Belzona Shaft Repair at Cement Plant

ID: 8058

Industry: *Cement*
Application: *MPT-Mechanical Power Transmission*

Customer Location: *Cement Plant, Yorkshire, UK*
Application Date: *September 2017*

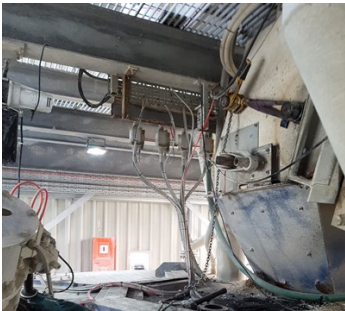
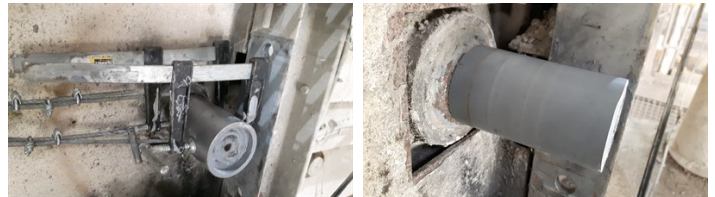
Photograph Descriptions

Heavy wear had occurred and required repairing before potential equipment failure.

- * Worn shaft prior to Belzona repair ,
- * Surface preparation carried out and the former in place on the shaft ,
- * Former clamped in position and filled with Belzona 1111 ,
- * Former removed revealing fully cured Belzona 1111 prior to dressing down ,

Worn 90mm diameter shaft

The application was carried out in accordance with Belzona Know-How System Leaflet MPT-2. After thorough surface preparation, the Belzona 1111 was applied by brush to the repair area. A pre-made split former was positioned over the repair area with a clamp. All excess material was removed and the repair was left to fully cure before removal of the former.
