Belzona helps in the protection of a surface under the granule scraper.

ID: 8060

Application: FPA-Floor Problem Areas

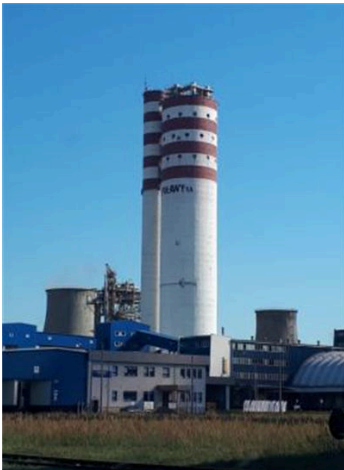
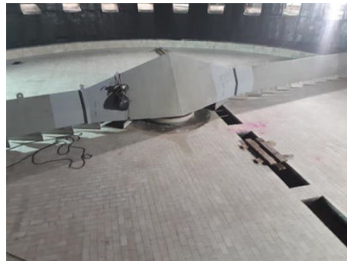
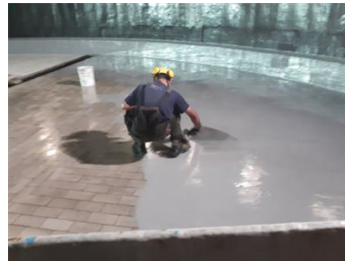
Corrosion of concrete and surface due to the scraper moving the granules around the area.

- * Application Area Picture ,
- * Area to be treated under the scraper ,
- * Applying Belzona 4151 & Belzona 5811 ,
- * Application Completed ,

Repair any surface damaged concrete areas with Belzona 4151 Sealing the surface under the scraper using Belzona 5811.
