# Belzona keeps the hose floating

ID: 8065

Industry: Oil & Gas  
Application: SOS-Ships and Offshore Structures

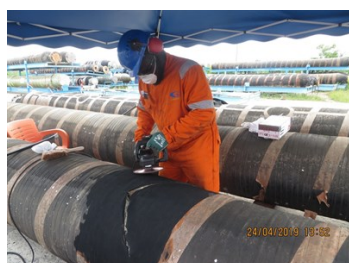
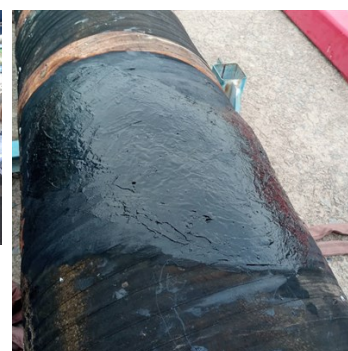
The offloading hose used to carry petroleum products from offshore to the shore had cuts caused by debris in the sea, contact with passing boats and marine life.

- \* Damaged Area ,
- \* Surface Preparation ,
- \* Degreasing & removing debris ,
- \* Completed repair ,

Surface cuts of floating hoses. The hoses have been brought out of the water into a courtyard for repair due to the damage.

Belzona repairs of the floating flexible hose were carried out in accordance with Belzona Know-How System Leaflet SOS – 12. Floating hose surface was prepared using mechanical tools to attain a surface roughness. Belzona 9111 Degreaser/ cleaner was used to clean and removed debris from the substrate surface and left to dry. Belzona 2911 conditioner was applied unto the substrate for bonding and allowed to become touch dry, Belzona 2111 was then applied to rebuild the external cut on the flexible/rubber hose. Belzona 9341- reinforcement Tape was used with Belzona 2111(MP Hi-Build Elastomer)

As the damage to the hose is only on the outer layers, the hose still has structural integrity - therefore the customer wanted to avoid unnecessary replacement, which carries a greater cost and lead time than the Belzona repair. The Belzona repair was carried out and fully cured within 24 hours, allowing the hose to go back into service quickly.
