Belzona cold repair to a leaking pipe joint

ID: 8066

Customer Location: Ghana
Application Date: June 2019

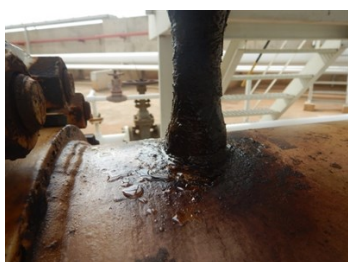
A 1" pipe branching from the 14" main line has a crack and a leak at the joint area. As the line contains flammable fluids hot work is not an option.

- * Defect area ,
- * Surface Preparation Complete ,
- * Application in progress ,
- * Completed repair ,

Application was carried out in accordance with Belzona Know How System Leaflet VPF – 11. (Application method (a) The surface of the pipe was properly prepared with the bristle blaster surface preparation tool to achieve adequate surface roughness. Belzona 9111 was used to wash down the area to be repaired. In order to remove all dirt, grease and surface contaminants. Selected Belzona 1212 was mixed in accordance with the Belzona Instructions For Use. Thin layer of Belzona 1212 was applied unto the prepared areas and pushing it well into the prepared profile/leak. Length of Belzona 9341 was wet out and then applied around the circumference of the pipe. Both 1" branch line and the 14" line. The reinforcement tape was firmly wrapped until the Belzona 1212 is forced through the outer surface. Further layer of Belzona 1212 was applied to completely encapsulate the repair area.
