# Belzona Rebuilds and Protects Oil Tank

ID: 8067

Customer Location: Tunisia  
 Application Date: 2009

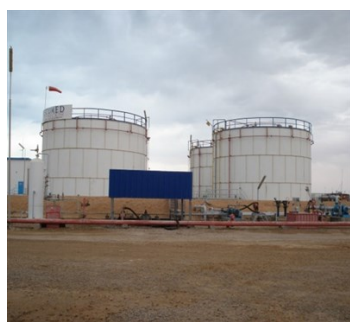
- \* 1. External view of the storage tank ,
- \* 2. Pitting at the base of the tank ,
- \* 3. Belzona 1121 plate bonding ,
- \* 4. Internal coating of Belzona 5811 ,

Crude oil storage tank.

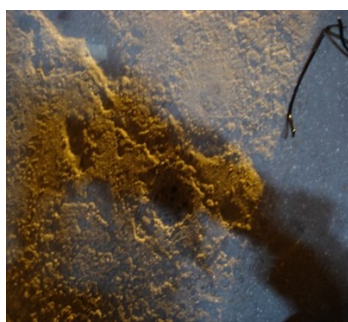
Severe pitting was present at the base and lower section of the tank wall, this was a result of a mixture of water and also hydrocarbons found within the crude oil. As the density of the water is greater than the hydrocarbons, the water will sit at the bottom of the tank causing corrosion in this lower section of the tank.

Belzona 1121 was used to fill in the pits of the localized damaged areas and plate bonding was used to restore any larger damaged areas on the base of the tank. Once the structure of the tank had been restored, 2 coats of Belzona 5811 were applied to the lower section of the tank.
