# Belzona Repairs Flange Surface of a Floating Hose

ID: 8069

Customer Location: Ghana  
Application Date: April 2019

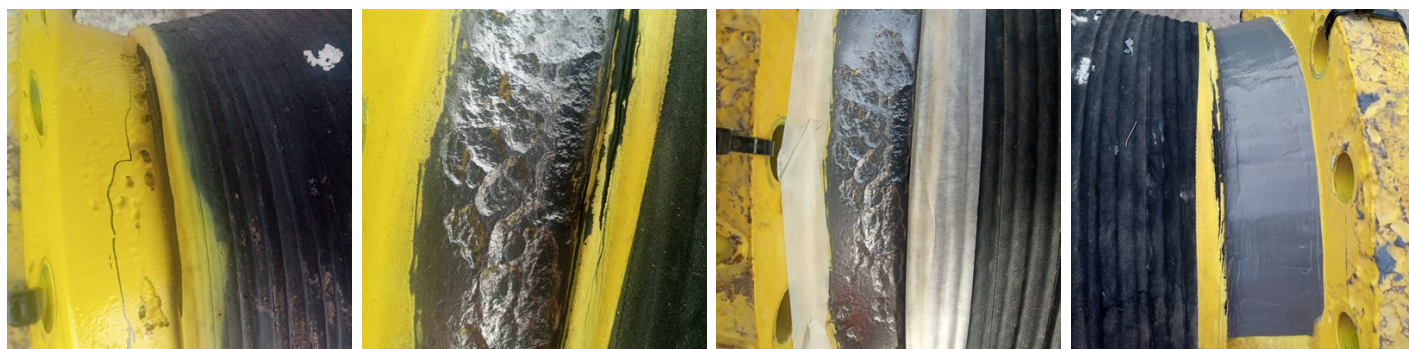
*The neck of the floating hose leading to the flange area is suffering from severe pitting due to the corrosive and erosive sea water environment, several mm of steel has been lost.*

- \* Overview of the damaged area ,
- \* Surface preparation ,
- \* Defect area marked out and debris removed ,
- \* Completed application ,

Application was achieved out in accordance with Belzona Know How System Leaflet VPF – 9. The surface of the flange (defect area) was properly prepared with the bristle blaster surface preparation tool to achieve adequate surface roughness and Sa 2.5 cleanliness. Belzona 9111 was used to remove any debris from the flange defect area after the surface was successfully prepared and allowed to dry. Belzona 1212, excellent surface tolerant product was applied to rebuild to a desired shape and form.
