Belzona Magma Foundations Repair at Cement Factory

Repair of the foundations of the clinker furnace head at a large cement factory in Poland.

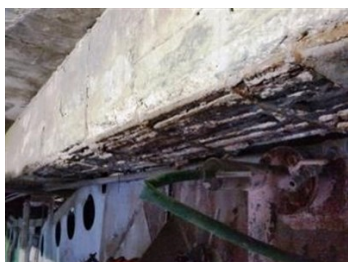
During long-term operation under varying climatic conditions and high temperatures, the foundation (supports, beams) was degraded under the head of the clinker furnace.

- * Degraded Concrete ,
- * Metal Mould to pour Belzona 4111 ,
- * Applying Belzona 4111 ,
- * Finished Job. ,
