# Belzona Magma Foundations Repair at Cement Factory

ID: 8070

Repair of the foundations of the clinker furnace head at a large cement factory in Poland.

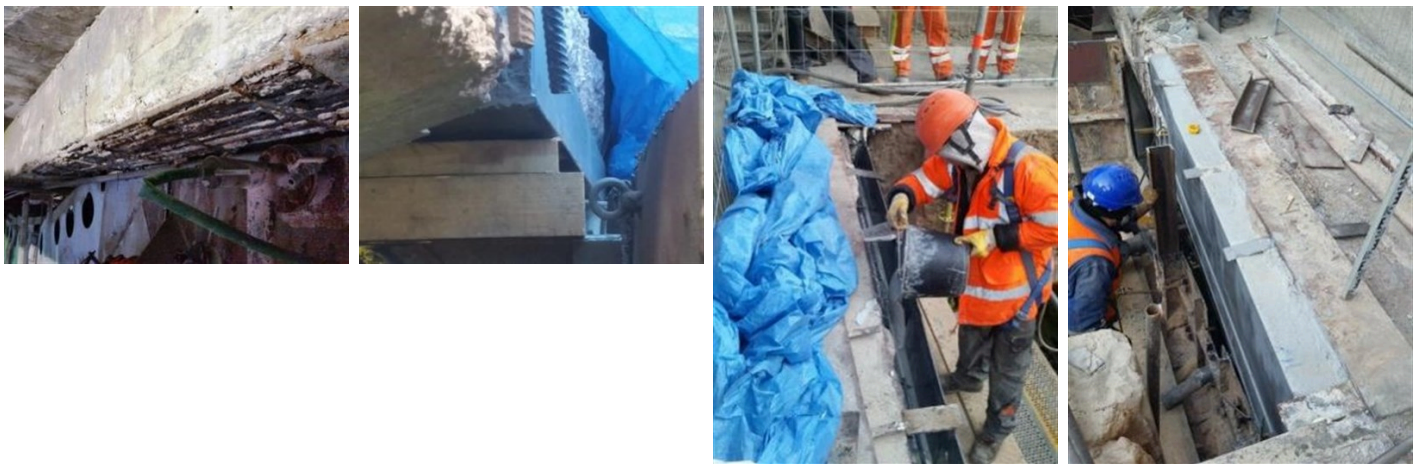
*During long-term operation under varying climatic conditions and high temperatures, the foundation (supports, beams) was degraded under the head of the clinker furnace.*

- \* Degraded Concrete ,
- \* Metal Mould to pour Belzona 4111 ,
- \* Applying Belzona 4111 ,
- \* Finished Job. ,

The application was completed in accordance with an adapted version of Belzona System Leaflet WPA-4. A metal mould was created around the affected area to pour the Belzona 4111 into to ensure a perfect finish.
