Turbine Restored and Protected with Belzona

ID: 8071

Problem

Repair of a turbine suffering from corrosion and erosion.

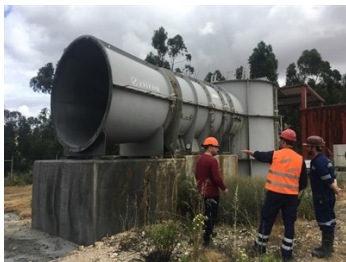
- * 1. Overview of the blower ,
- * 2. Eroded-corrode turbine ,
- * 3. Belzona 1331 being applied to the turbine ,
- * 4. blower back in service ,

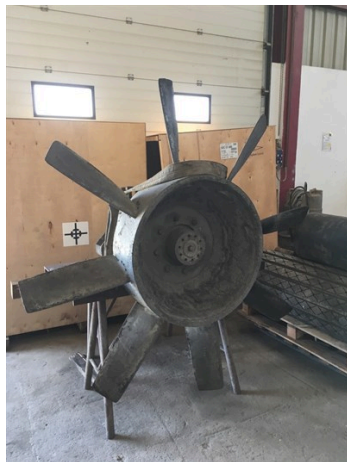
General erosion-corrosion on the turbine of a blower used as part of copper mining process. The erosion had caused a loss of material which could result in balancing issues.

Application carried out in accordance with Belzona Know-How System leaflet FBC-01 & FBC-02. The turbine was grit blasted down to SA 2.5 and then the lost structure was rebuilt with Belzona 1311. Finally 2 coats of Belzona 1331 was applied to prevent further corrosion-erosion.
