High Temperature Abrasion Protection with Belzona

ID: 8072

Industry: Steel & Metal Processing
Application: MPT-Mechanical Power Transmission

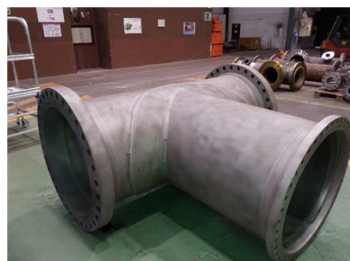
- * 1. The newly fabricated pipe section ,
- * 2. Internal surface prepared ,
- * 3. Belzona 1511 and Belzona 9811 tiles applied ,
- * 4. Belzona 1813 applied and Belzona 1391T top coat ,

The application was carried out in accordance with a modified version of Belzona Know-How System Leaflet SHM-7. The surface was prepared using grit blasting to the required cleanliness and profile as detailed in the Belzona Instructions for use. Belzona 1511 was applied to the surface and the Belzona 9811 alumina tiles bonded into the material. Belzona 1813 was used to grout between the tiles. A top coat of Belzona 1391T was then applied, to encapsulate the system and give a smooth finish.
