Belzona Ball Mill Trunnion Repair

Repair of the trunnion section of a grinding mill

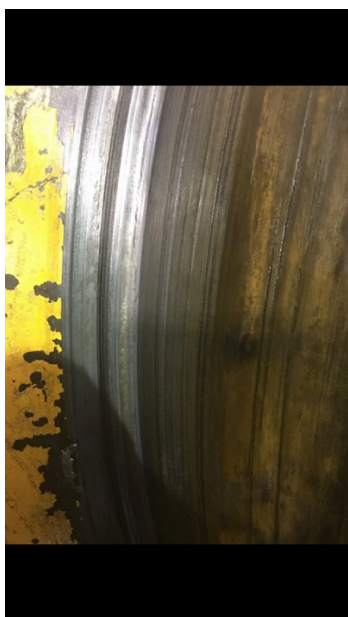
Wear caused over time by the rotating mill grinding against the trunnion section. Also abrasion from the minerals and ores being ground as part of the mining process.

- * 1. Damaged trunnion section ,
- * 2. Surface preparation using an MBX ,
- * 3. Applying the Belzona 1121 ,
- * 4. Final application ,
