Belzona Ball Mill Trunnion Repair

ID: 8074

Repair of the trunnion section of a grinding mill

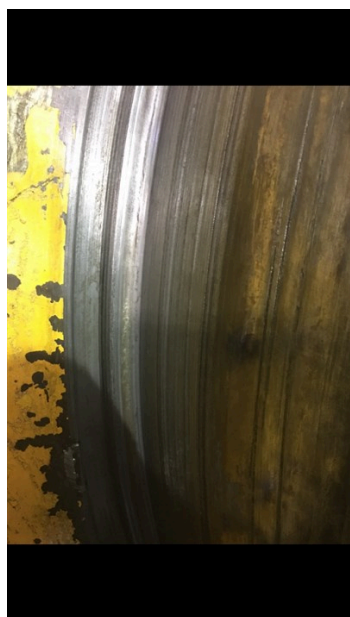
Wear caused over time by the rotating mill grinding against the trunnion section. Also abrasion from the minerals and ores being ground as part of the mining process.

- * 1. Damaged trunnion section ,
- * 2. Surface preparation using an MBX ,
- * 3. Applying the Belzona 1121 ,
- * 4. Final application ,
