# Belzona secures a lifting winch

Application: SHM-Solids Handling Machinery

Chocking of heavy machinery winch.

Lifting winch being secured on the deck of a dredging vessel

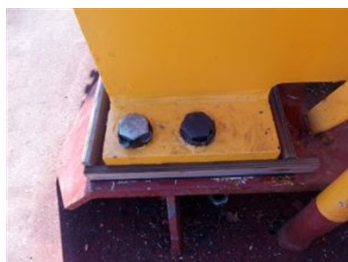
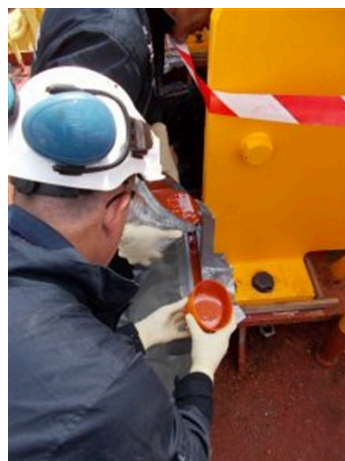
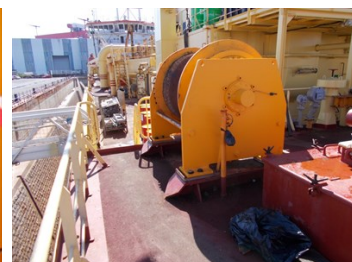
- \* Dredging vessel ,
- \* Area marked and dammed, ready for application ,
- \* Pouring in progress ,
- \* Completed application ,

The installation was carried in accordance with Belzona System Leaflet GSS-12.

The 4 supporting pads were chocked using Belzona 7111 in order to ensure optimum load transmission as well as long term

protection against vibration. The fast curing properties of the material were a key factor for the operator of the ship.
