# Belzona secures a lifting winch

*Chocking of heavy machinery winch.*

Lifting winch being secured on the deck of a dredging vessel

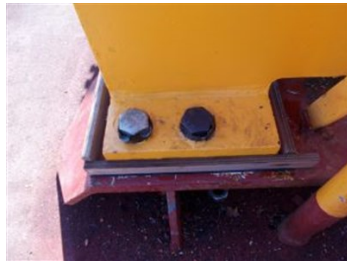
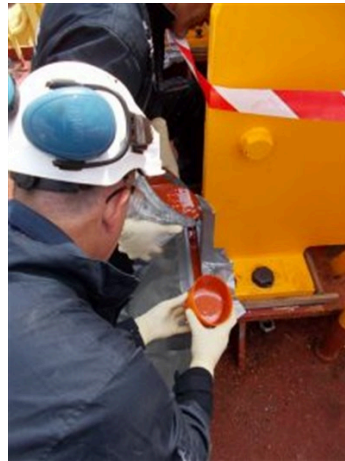
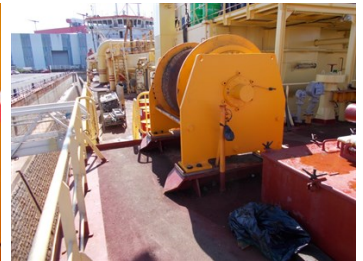
- \* Dredging vessel ,
- \* Area marked and dammed, ready for application ,
- \* Pouring in progress ,
- \* Completed application ,

The installation was carried in accordance with Belzona System Leaflet GSS-12.

The 4 supporting pads were chocked using Belzona 7111 in order to ensure optimum load transmission as well as long term

protection against vibration. The fast curing properties of the material were a key factor for the operator of the ship.
