Belzona secures a lifting winch

ID: 8075

Application: SHM-Solids Handling Machinery

Lifting winch being secured on the deck of a dredging vessel

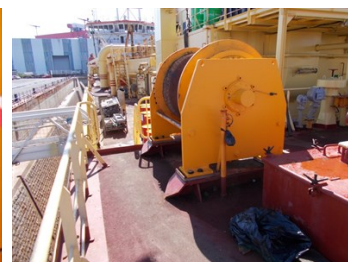
- * Dredging vessel ,
- * Area marked and dammed, ready for application ,
- * Pouring in progress ,
- * Completed application ,

The installation was carried in accordance with Belzona System Leaflet GSS-12.

The 4 supporting pads were chocked using Belzona 7111 in order to ensure optimum load transmsion as well as long term

protection against vibration. The fast curing properties of the material were a key factor for the operator of the ship.
