# Belzona protect new water distribution pipework

Customer Location: *Water treatment plant, France*

*Protection against corrosion / erosion on new sections of pipework*

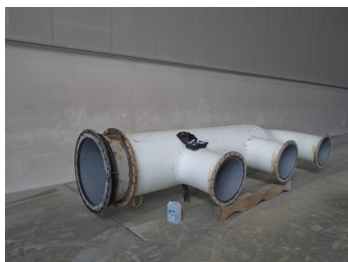
- \* 1- Section of pipework (4 in total) ,
- \* 2- Application of Belzona 5821 completed ,
- \* 3- Inspection in progress ,

New pipework system, 300m2 in total (including 4 large pipework sections, 52 bends and 5 tees)

Hand application of Belzona 5821 followed by a thorough inspection to ensure that the application was carried out as per the Instructions For Use.
