Belzona repairs pump caissons

ID: 8088

Customer Location: Azerbaijan - Offshore

Application Date: August 2018

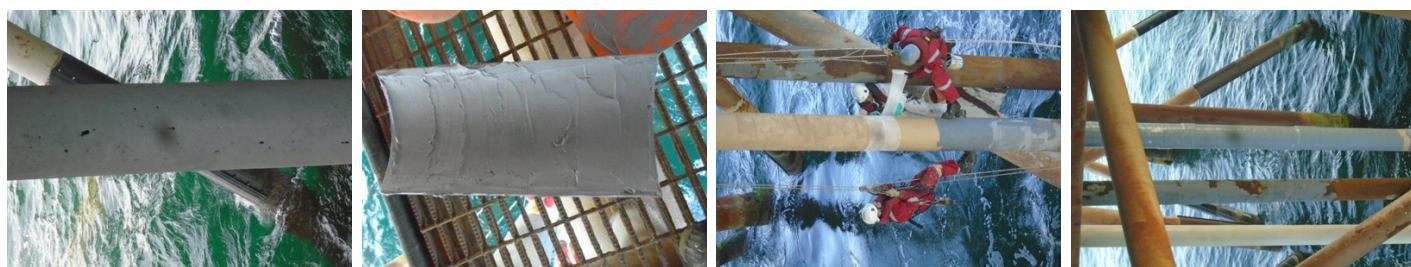
Photograph Descriptions

Through wall defects of pipe causing leakage of water with large areas of pitting.

- * Defective pipe ,
- * Doubler plate ,
- * Belzona 5831 1st coat ,
- * Belzona 5831 2nd coat ,

Pump caisson pipe suffering from external corrosion and through-wall defects

The application was completed in accordance with Belzona System leaflet VPF-11 and SOS-21. Through wall defects were repaired by plate bonding using Belzona 1212. Pitting was repaired with Belzona 1161 followed by 2 coats of Belzona 5831 with Reinforcement Sheet between the coats.
