Belzona 1812 in use at Peat Power Plant

ID: 8094

Industry: *General Industry*
Application: *SHM-Solids Handling Machinery*

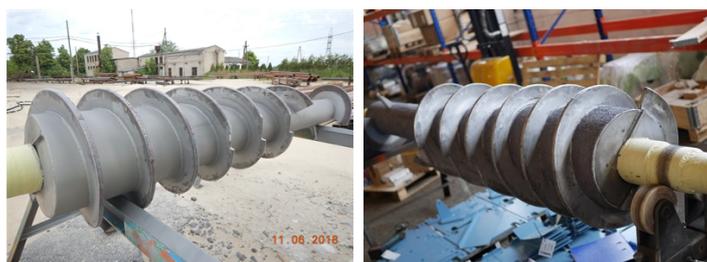
It is very time consuming and costly for the client. Welding would make the pipe fragile and very difficult to use post-process.

- * Screw before Belzona coating ,
- * Screw complete with Belzona coating ,

The customer's drawing shows that the screw tube must be welded with a hard facing CASTOLIN 5006. Screw was used for transporting peat.

Application was carried out in accordance with Belzona leaflet SHM-14. Grit blasting was used to prepare the surface, followed by a lining of Belzona 1812

Little down time for the customer and saving them money contributed to winning the job. According to the customer feedback, the screws have been working for a year and there is no sign of wear.
