# Belzona 1812 in use at Peat Power Plant

Application: SHM-Solids Handling Machinery

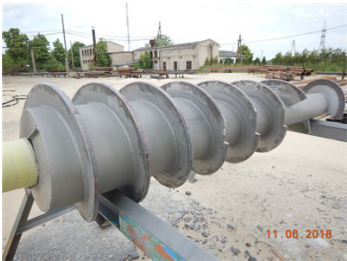
- \* Screw before Belzona coating ,
- \* Screw complete with Belzona coating ,

The customer's drawing shows that the screw tube must be welded with a hard facing CASTOLIN 5006. Screw was used for transporting peat.

Application was carried out in accordance with Belzona leaflet SHM-14. Grit blasting was used to prepare the surface, followed by a lining of Belzona 1812
