# Belzona Seals Rivet Tank

ID: 8098

Customer Location: Italy  
Application Date: 2018

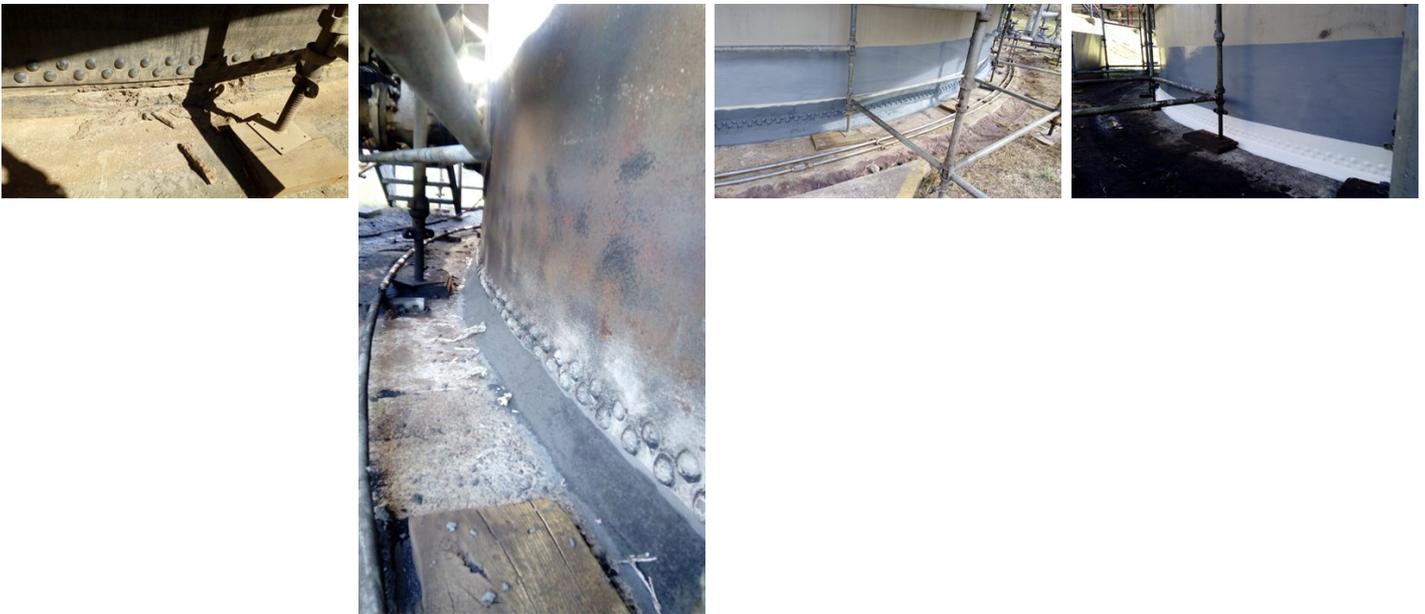
An existing coating had failed at the base of a rivet tank and degraded due to UV exposure. With the tank base unprotected moisture ingress was able to shoot underneath the tank as the tank expanded and contracted causing further corrosion.

- \* 1. Deteriorated base ,
- \* 2. Belzona 4111 chamfer angle ,
- \* 3. Belzona 5811 + 3111 first coat ,
- \* 4. Finished application ,

This application was carried out in accordance with system leaflet GSS-03. The base of the tank was grit blasted to Sa 2.5 before Belzona 4111 was used to rebuild and create a chamfer angle for the rain water to run off before installing the Belzona tank base sealing system. Once the angle had been created, Belzona 5811 was applied a meter above the application zone for added corrosion resistance. After, the Belzona 4111 was frost blasted and then the whole application areas was conditioned with Belzona 3921 before applying a 2 coat system of Belzona 3111 with the Belzona 9311 reinforcement sheet.
