Belzona Repairs Leaking Tank Roof

ID: 8101

Sealing holes on the roof of an oil tank.

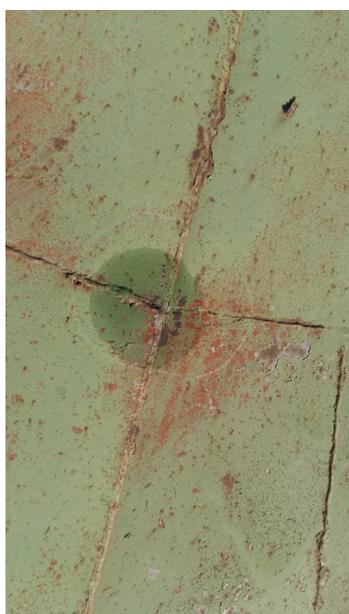
A tank roof has failed and started corroding at the weld seams. This was allowing water to seep in through these holes causing contamination problems for the solution within the tank.

- * 1. Overview of the tank roof ,
- * 2. Water ingress at the weld seams ,
- * 3. Belzona 1161 being applied ,
- * 4. Finished application with Belzona 3111 ,

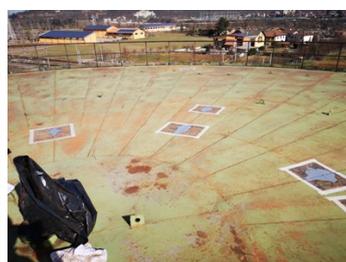
Previous welding had introduced heat activated zones into the tank roof resulting in weakness and corrosion at the weld seams. Welding the tank again would have created the same problems and that's why the Belzona cold applied solution was used.
