# Belzona Rejuvenates Storage Tank

ID: 8102

Refurbishment of the internal base of a storage tank.

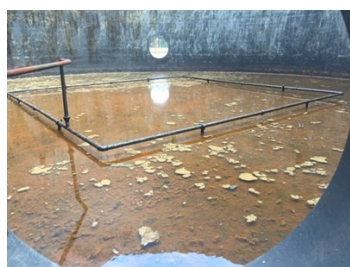
Due to a mixture of water and hydrocarbons, the bottom of the tank had started to corrode where the water sits. This is because the density of the water is greater than the hydrocarbons and as the steel is unprotected the tank corroded at the bottom.

- \* 1. Before application ,
- \* 2. Grit Blasted surface ,
- \* 3. Coating of Belzona 5811 ,
- \* 4. Finished application ,

This application was carried out in accordance with system leaflet TCC-05. The storage tank was drained and power washed to get rid of any loose contaminants and debris. Once dry, the tank was grit blasted to Sa 2.5 before 2 coats of Belzona 5811 were applied to the floor and about 1 meter up the internal walls of the storage tank.
