Belzona Rejuvenates Storage Tank

ID: 8102

Customer Location: Italy
Application Date: 2016

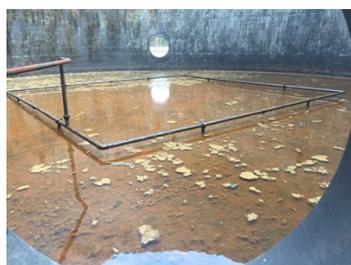
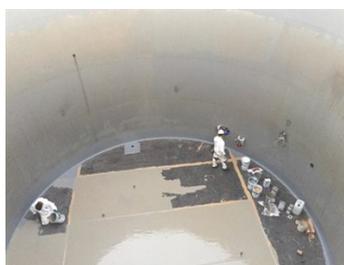
Due to a mixture of water and hydrocarbons, the bottom of the tank had started to corrode where the water sits. This is because the density of the water is greater than the hydrocarbons and as the steel is unprotected the tank corroded at the bottom.

- * 1. Before application ,
- * 2. Grit Blasted surface ,
- * 3. Coating of Belzona 5811 ,
- * 4. Finished application ,

This application was carried out in accordance with system leaflet TCC-05. The storage tank was drained and power washed to get rid of any loose contaminants and debris. Once dry, the tank was grit blasted to Sa 2.5 before 2 coats of Belzona 5811 were applied to the floor and about 1 meter up the internal walls of the storage tank.

Belzona 5811 was used as it offers long term corrosion resistance in immersion.
