# Belzona 1321 Titanium Pump Repair

ID: 8104

Industry: Oil & Gas  
Application: CEP-Centrifugal Pumps  
Substrate: Titanium  
Products: \* Belzona 1321 (Ceramic S-Metal) ,

Customer Location: Northern Poland  
Application Date: 2019

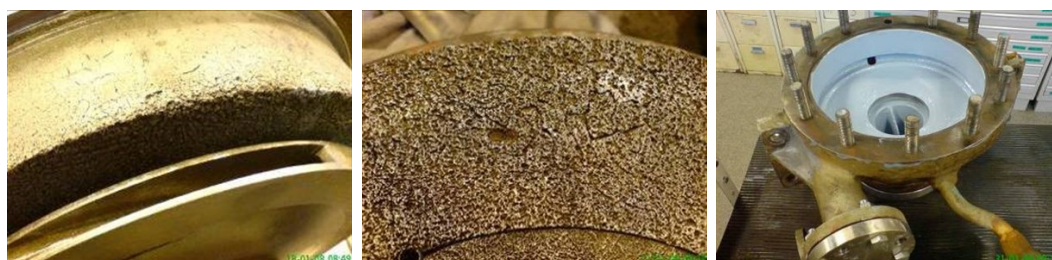
The KSB pumps were typically only lasting 3 months due to significant damage to the titanium substrate operating at a temperature of 60°C. The refinery contacted the local distributor for a Belzona solution to improve longevity of the pump.

- \* Picture 1: Close up of damage to substrate. ,
- \* Picture 2: Close up of damage to substrate. ,
- \* Picture 3: Completed Belzoan 1321 Coating. ,

One of the largest refineries in Poland has significant damage to the titanium substrate of a KSB pump.

The local distributor coated the pump with three layers of Belzona 1321 to extend the working life of the pump and protect the titanium substrate from further damage. The application was completed in accordance with Belzona System Leaflet CEP -01.

Since applying the Belzona 1321 the pumps are now typically lasting 9 months saving the client money on down time and repairing more frequently.
