Belzona Pneumatic Rubber Fender Repair

ID: 8115

Industry: Oil & Gas
Application: SOS-Ships and Offshore Structures

Customer Location: Aban Offshore Ltd. Navi Mumbai, India
Application Date: October 2019

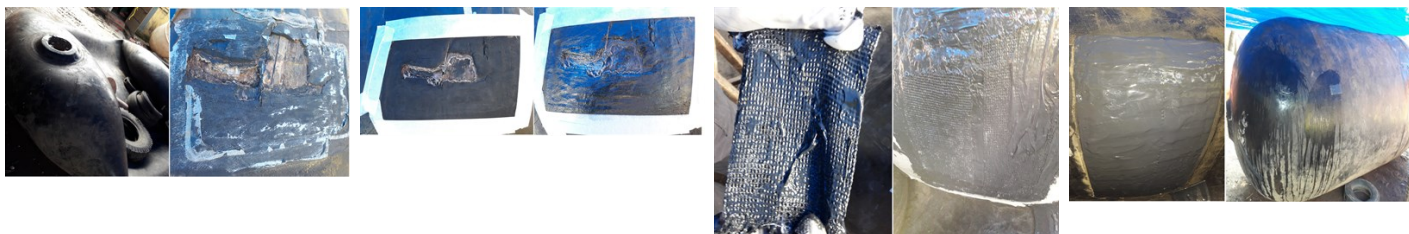
Photograph Descriptions

Fenders were wrapped with tyres & chains for additional protection, which damages the fender & it become worn & punctured. Hence they were in need of a full service or replacement.

- * Deflated Fender & Punctured Area ,
- * Surface Prepared & Conditioning ,
- * Application With 2211 & 9341 ,
- * Finished Application ,

The Aban offshore company sent a fender which was being used to protect rig platform legs & they had become worn and punctured over time.

Application was carried out in accordance with Belzona Know-How System Leaflet SOS-12. Surfaces were prepared using a MBX machine. After Conditioning the areas with 2921 were rebuilt with Belzona 2211 incorporating Belzona 9341 (Reinforcement Tape).
