Belzona Elastomer Used to Repair Torn Conveyor Belts at Recycling Plant

ID: 8126

Customer Location: *Recycling Plant - Zurich, Switzerland*
Application Date: *April 2019*

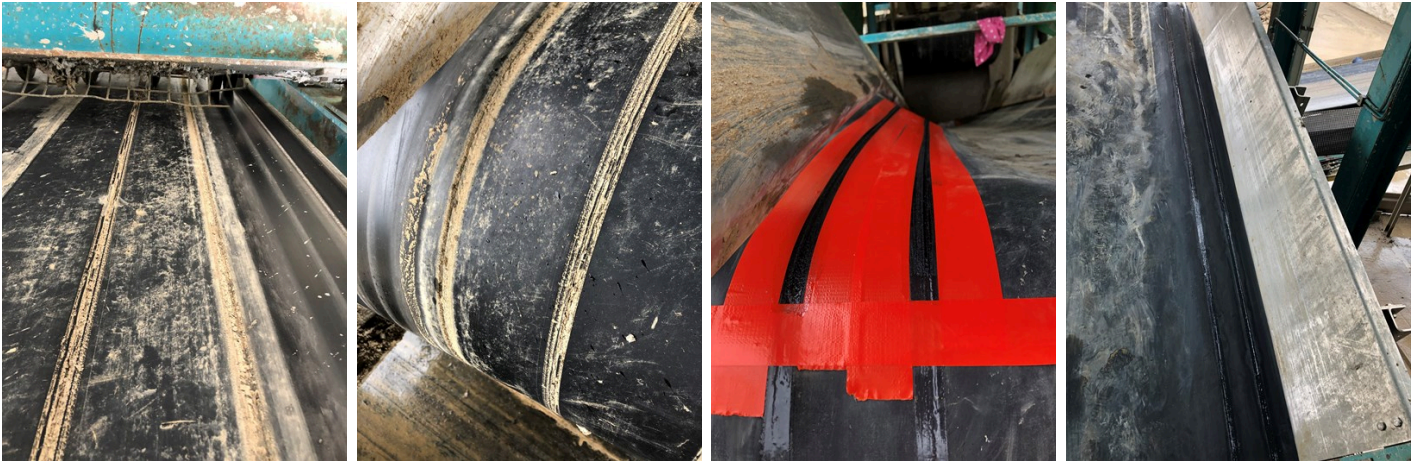
Photograph Descriptions

- * Damage along the length of the conveyor belt ,
- * Heavy scoring and tears resulted in shutdown ,
- * The repair area masked off for application of Belzona 2311 ,
- * The Belzona repair allowed for a return to service the very next day ,

A recycling plant specialising in urban mining, extracting and reusing building materials from previous sites e.g. concrete. At the facility, a large conveyor belt had become caught on a defective scraper, causing a linear tear over 32m along the rubber.

The application was carried out in accordance with Belzona Know-How System Leaflet SHM-1. Any loose parts of the rubber were first cut away, before the substrate was prepared using a rotary wire brush. The entire area was subsequently cleaned using Belzona 9111. The defected areas were masked off and conditioned, before Belzona 2311 was applied to the surface. This is a fast-curing material that is cold-curing and requires no specialist application tools. To reinforce the repair Belzona 9341 (a flexible and strong fabric mesh) was embedded into the elastomer and then encapsulated with a secondary application of Belzona 2311.

Due to the fast turnaround required, the Distributor carried out the repairs on the same day. The application took 7 hours to complete compared to replacement, which would have caused approximately 3 times the amount of downtime. This allowed the plant to run the conveyor belt the very next day. This belt is still in use after 9 months without any problems at the repair points.
