# Shopping centre step with Belzona grip system

ID: 8128

Industry: *Buildings & Structures*  
Application: *FPA-Floor Problem Areas*  
Substrate: *Stone*  
Products: *\* Belzona 4411 Granogrip ,*  
*\* Belzona 9221 Surefoot white ,*

Customer Location: *Paisley, Scotland*  
Application Date: *October 2018*

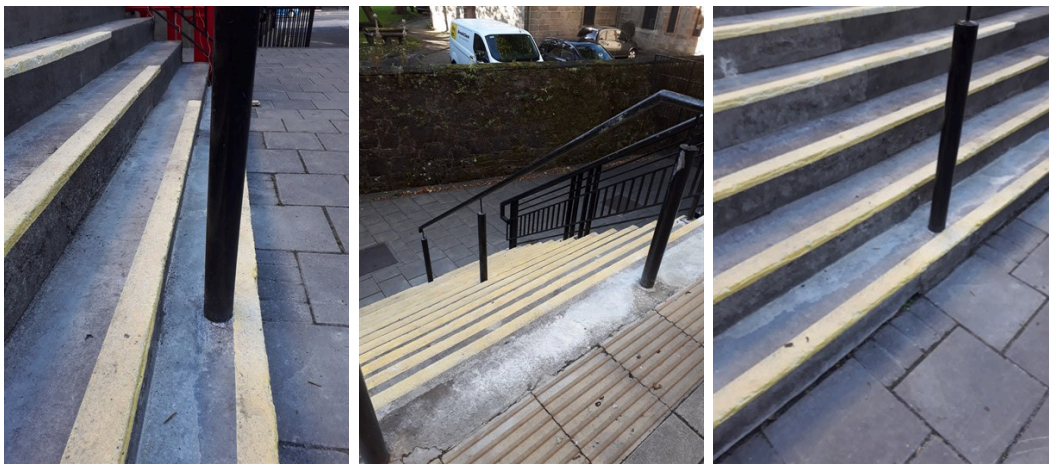
- \* Close up of application ,
- \* Top down view ,
- \* Bottom view ,

A set of stone steps leading to the entrance of a shopping centre was identified as a potential slip hazard in wet or icy conditions. A hard wearing, easy to see grip system was required to give positive traction to pedestrians using the steps.

The step nosings were abraded with a floor grinder. The Belzona 4411 system was then applied by brush before the Belzona 9221 was sprinkled on top to form the grip system

The application was able to be carried out over one day so minimal disruption to the area was caused
