# Belzona Repairs To Protect Tank Supports

ID: 8129

Diesel storage tank showing signs of corrosion.

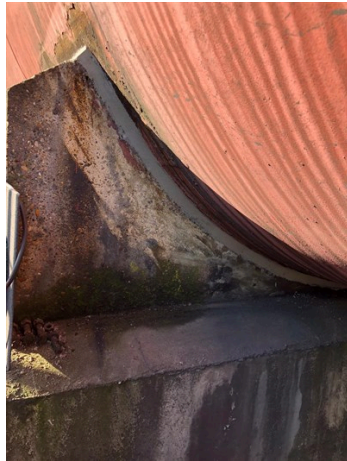
The tank and concrete saddles were showing some minor signs of corrosion at the joints. This was caused by standing water in these areas. The damage to the tank coating and concrete were only minimal, however if they were not repaired, the damage would have continued to deteriorate causing potential failure of the tank or the supports in the future.

- \* Area of concern ,
- \* Belzona concrete rebuild completed ,
- \* Conditioner applied ,
- \* Completed repair to tank supports ,

The failed concrete on the tank support was removed using hand tools. The repair area was then prepared to remove any remaining loose particles and dirt from the concrete areas. The concrete was then conditioned and rebuilt to match the surrounding concrete supports using Belzona 4131. Surface preparation of a 100mm band on the concrete and the tank was then undertaken, again using hand tools to remove any failing coating and rust. A two coat, reinforced system of Belzona 3131 was then used to create a seal between the tank and the concrete. A band of 200mm around the tank was applied to concrete interfaces.
