BELZONA UPGRADES SPIRITS CONTAINMENT AREA

ID: 8133

Customer Location: Distillery, Scotland
Application Date: 2011

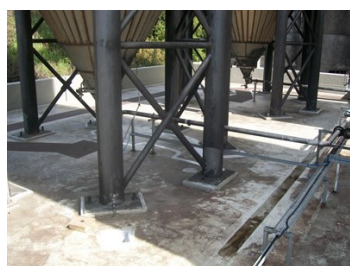
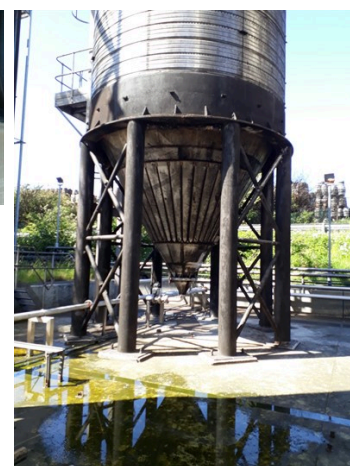
Photograph Descriptions

The existing protective system had failed. The chemical containment area could no longer be relied upon to prevent liquid loss into the groundwater/watercourse in the event of a spillage.

- * 1. Containment area prior to Belzona Application ,
- * 2. Application of Belzona 5811 underway ,
- * 3. Completed Application ,
- * 4. Area revisited in 2019 ,

Spirit containment area/bund became damaged over time.

Application was carried out in accordance with Belzona Know-How System Leaflet TCC-15. Belzona 4131 and Belzona 4141 were used to repair the degraded sections of the walls and to create fillets to all horizontal and vertical corners of the bund. The floor was screeded with Belzona 4131 at 6mm to provide maximum impact resistance. A two coat system of Belzona 5811 was then applied

to all the internal surfaces of the bund.

The Belzona system provides excellent resistance to permeation. The reinforcement of wall and floor joints will ensure long term containment without cracking or breaks in the bund lining. The coating is a bit dirty (covered in whisky black fungus) but otherwise in perfect condition 8 years on!
