BELZONA UPGRADES SPIRITS CONTAINMENT AREA

Industry: General Industry
Application: TCC-Tanks and Chemical Containment Areas
Substrate: Concrete
Products: * Belzona 4131 (Magma-Screed) ,
 * Belzona 4141 (Magma-Build) ,
 * Belzona 5811 (Immersion Grade) ,

Customer Location: Distillery, Scotland
Application Date: 2011

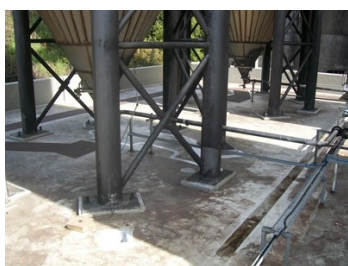
Photograph Descriptions

The existing protective system had failed. The chemical containment area could no longer be relied upon to prevent liquid loss into the groundwater/watercourse in the event of a spillage.

- * 1. Containment area prior to Belzona Application ,
- * 2. Application of Belzona 5811 underway ,
- * 3. Completed Application ,
- * 4. Area revisited in 2019 ,

Spirit containment area/bund became damaged over time.

Application was carried out in accordance with Belzona Know-How System Leaflet TCC-15. Belzona 4131 and Belzona 4141 were used to repair the degraded sections of the walls and to create fillets to all horizontal and vertical corners of the bund. The floor was screeded with Belzona 4131 at 6mm to provide maximum impact resistance. A two coat system of Belzona 5811 was then applied

to all the internal surfaces of the bund.

The Belzona system provides excellent resistance to permeation. The reinforcement of wall and floor joints will ensure long term containment without cracking or breaks in the bund lining. The coating is a bit dirty (covered in whisky black fungus) but otherwise in perfect condition 8 years on!
