BELZONA REDUCES DREDGING PUMP REFURBISHMENT COSTS

ID: 8134

Customer Location: Dredging Operator, Teesside, UK
Application Date: October 2019

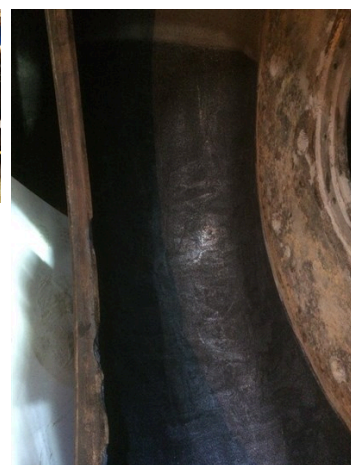
The dredger pump had suffered significant localised damage with several areas requiring repair. The damaged areas extended into nozzles, but the worst attack had been in the belly of the pump.

- * 1. Hopper Dredger Vessel ,
- * 2. Initial damage to pump ,
- * 3. Worst effected area of pump ,
- * 4. Finished application of Belzona 1814 ,

The application was carried out in accordance with Belzona system leaflets CEP-3 and CEP-5. After treating surfaces with SaltAway to remove soluble salts, the areas were grit blasted and degreased. Belzona 1311 was used to fill localised pitting and to rebuild edges. Finally, the belly of the pump was protected with 3mm of Belzona 1814, which was feathered towards the edges.

Belzona 1814 was chosen as it offered excellent abrasion resistance at a more affordable cost. This new bulk filled abrasion resistant material offered significant savings over the more traditional materials, and costs were nearly halved.
