Belzona 1111 & Belzona 4311 reconstructs and protects chemical pump

Industry: Sugar
Application: CEP-Centrifugal Pumps
Substrate: Cast Iron
Products: * Belzona 1111 (Super-Metal) ,
* Belzona 9111 (Degreaser) ,
* Belzona 4311 (Magma CR1) ,
* Belzona Flange Face Forming Kit. ,

Customer Location: Switzerland
Application Date: 15.11.2019

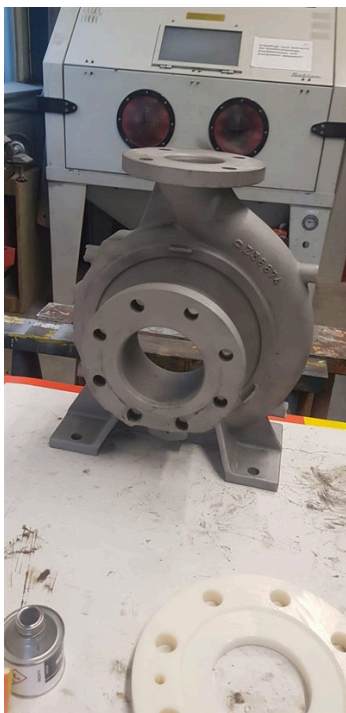
The chemicals attacked or completely destroyed the flange surfaces and parts of the housing.

- * Image 1: Damaged Pump ,
- * Image 2: Flange Reform ,
- * Image 3: Internal Coating Complete ,
- * Image 4: Flange Reformed. ,

Re-built with Belzona 1111 with the use of the Flange Face forming kit and then protected with a Belzona 4311 in accordance with Belzona Know-How CEP-03.
