# 90 Year Old Cast Iron Lake Discharge System

ID: 8146

Customer Location: Ft. Worth Texas  
Application Date: Nov 2019

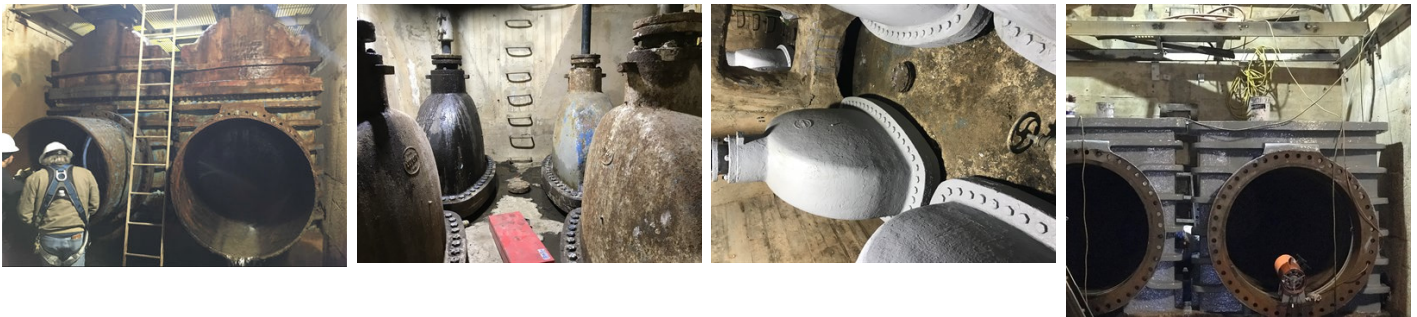
## Photograph Descriptions

*There was no way to replace the old bonnets, valves and pipe without bringing in a crane to take the old bonnets up 100ft to the top. The customer would have had to build a special way to bring them through the vertical tunnel without damaging the 90yr old concrete which could have weakened the structure. Customer needed a solution to keep the existing valves, bonnets and pipes in place for several years to come. The age of the cast iron and the environment had created heavy corrosion in the area.*

- \* 1. Bonnets, valve bodies and pipe prior to Blasting ,
- \* 2. Bonnets prior to blasting ,
- \* 3. Bonnets coated ,
- \* 4. Valve bodies and pipe coated. ,

Application was carried out by abrasive blasting the cast iron to SSPC SP10, whilst keeping a heater running in the area to keep the temperatures in the mid 60's f (>15c), raising the temp of the material to between 68-70F (20c to 21c) for the Belzona 5811. The first coat was applied, a second coat was applied within 24hrs to ensure proper coverage on the valve bodies. On the bonnets and pipe, Belzona 5831ST was applied whilst controlling the running water in the pipe with a makeshift dam. On the bonnets that were sweating, the surface was grit blasted and dried before applying Belzona 5831ST immediately.
