# Renovation of a liquid cyclone head with Belzona

ID: 8148

Inside of a liquid cyclone head for paper

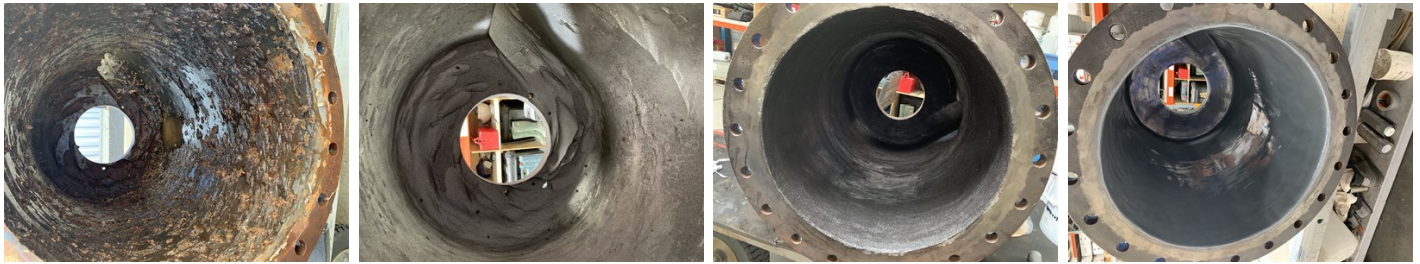
*The piece of equipment was badly damaged by erosion caused by the paper paste which is very abrasive.*

- \* Liquid cyclone head badly damaged ,
- \* After grit blasting ,
- \* After Belzona 1814 application ,
- \* Completely renovated after Belzona 1321 application ,

Application was carried out in accordance with Belzona System Leaflet VPF-01 and VPF-02. The corroded metal structure was blasted back to bare metal using grit blasting and the eroded areas were rebuilt applying Belzona 1814 with spatula. Belzona 1321 was applied with brush to protect against future erosion/corrosion.
