BUTTERFLY VALVE REFURBISHED WITH BELZONA

ID: 815

Customer Location: Water supply station, Egypt
Application Date: July 2006

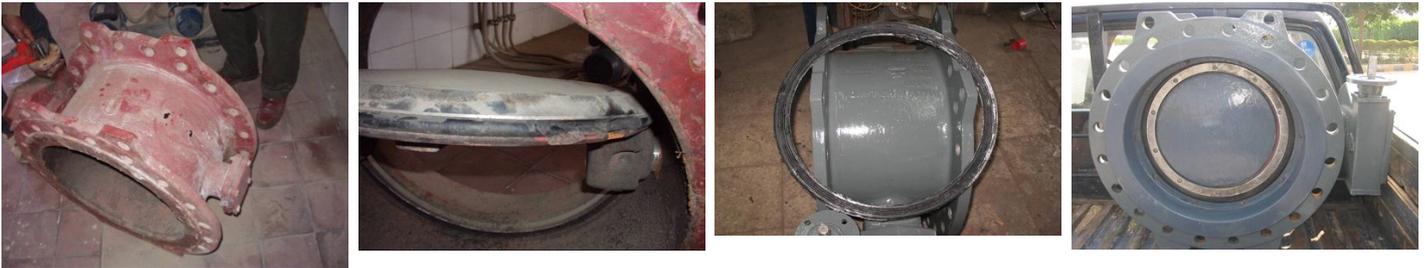
Photograph Descriptions

Body badly corroded sand holed in places. In addition rubber seal on valve disc completely deteriorated.

- * General view of the valve ,
- * The worn out rubber seal ,
- * Rubber seal was perfectly cast ,
- * Valve rebuilt and coated, application complete ,

Corrosion protection was made in accordance with Belzona Know-How System Leaflet VPF-2. The rubber seal was cast in accordance with Belzona Know-How System Leaflet CEP-9.

Belzona performed complete repair and protection to the valve body, disc and rubber seals.
