# BUTTERFLY VALVE REFURBISHED WITH BELZONA

Industry: Water / Wastewater

Customer Location: Water supply station, Egypt

Application Date: July 2006

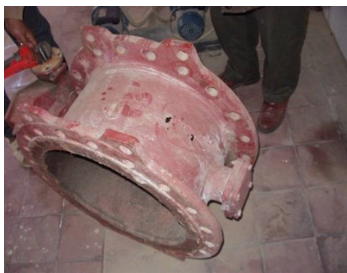
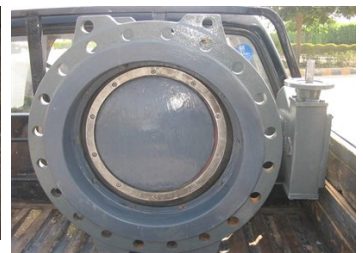
Body badly corroded and holed in places. In addition rubber seal on valve disc completely deteriorated.

- \* General view of the valve ,
- \* The worn out rubber seal ,
- \* Rubber seal was perfectly cast ,
- \* Valve rebuilt and coated, application complete ,

Corrosion protection was made in accordance with Belzona Know-How System Leaflet VPF-2. The rubber seal was cast in accordance with Belzona Know-How System Leaflet CEP-9.

Belzona performed complete repair and protection to the valve body, disc and rubber seals.
