# Belzona 5721 LEP Solution for Cold Weather

Industry: Power  
Application:  
Substrate: Fiberglass/Gelcoat  
Products: \* Belzona 5721 ,

Customer Location: Wind Farm, Minnesota  
Application Date: September 2019

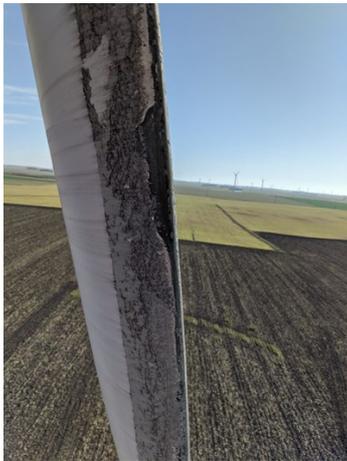
## Problem

Over time, the leading edge of wind turbine blades become eroded and lose efficiency and power production for the turbine generator. Because of the time of year, the weather was very cold, and a blade repair solution was needed to properly complete the repairs.

- \* 1. Damaged leading edge of wind blade ,
- \* 2. Belzona 5721 ready to mix ,
- \* 3. Finished Belzona 5721 application on leading edge ,
- \* 4. View of the Wind Farm ,

The application was carried out in accordance with a modified version of Belzona Know-How System Leaflet FBC-1. The blades were coated on the turbine at the operation site. The pitting and loss of surface on the leading edge was resurfaced with a filler product and rebuilt to dimensions. The surface area was sanded down with a mechanical sander and cleaned with a rag and non-residual solvent cleaner. One coat of Belzona 5721 at 20 mils (508µm) was applied.
