# Belzona 5721 LEP Solution for Cold Weather

ID: 8150

Customer Location: Wind Farm, Minnesota

Application Date: September 2019

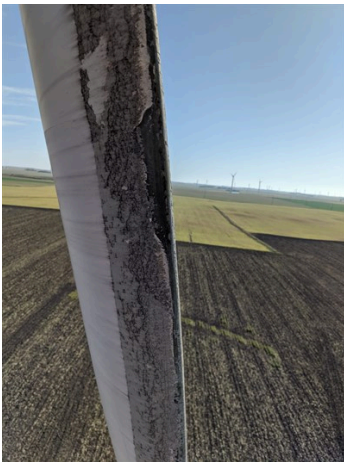
*Over time, the leading edge of wind turbine blades become eroded and lose efficiency and power production for the turbine generator. Because of the time of year, the weather was very cold, and a blade repair solution was needed to properly complete the repairs.*

- \* 1. Damaged leading edge of wind blade ,
- \* 2. Belzona 5721 ready to mix ,
- \* 3. Finished Belzona 5721 application on leading edge ,
- \* 4. View of the Wind Farm ,

The application was carried out in accordance with a modified version of Belzona Know-How System Leaflet FBC-1. The blades were coated on the turbine at the operation site. The pitting and loss of surface on the leading edge was resurfaced with a filler product and rebuilt to dimensions. The surface area was sanded down with a mechanical sander and cleaned with a rag and non-residual solvent cleaner. One coat of Belzona 5721 at 20 mils (508µm) was applied.
