Belzona 5721 LEP Solution for Cold Weather

ID: 8150

Customer Location: Wind Farm, Minnesota
Application Date: September 2019

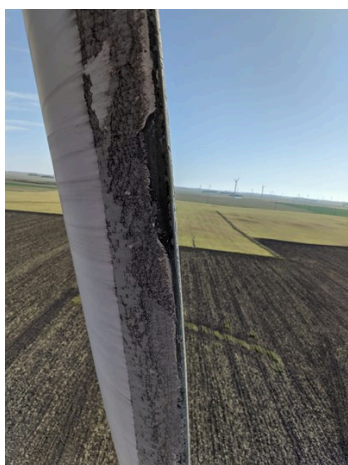
Over time, the leading edge of wind turbine blades become eroded and lose efficiency and power production for the turbine generator. Because of the time of year, the weather was very cold, and a blade repair solution was needed to properly complete the repairs.

- * 1. Damaged leading edge of wind blade ,
- * 2. Belzona 5721 ready to mix ,
- * 3. Finished Belzona 5721 application on leading edge ,
- * 4. View of the Wind Farm ,

The application was carried out in accordance with a modified version of Belzona Know-How System Leaflet FBC-1. The blades were coated on the turbine at the operation site. The pitting and loss of surface on the leading edge was resurfaced with a filler product and rebuilt to dimensions. The surface area was sanded down with a mechanical sander and cleaned with a rag and non-residual solvent cleaner. One coat of Belzona 5721 at 20 mils (508µm) was applied.
