Belzona 5721 LEP Solution for Cold Weather

Customer Location: Wind Farm, Minnesota

Application Date: September 2019

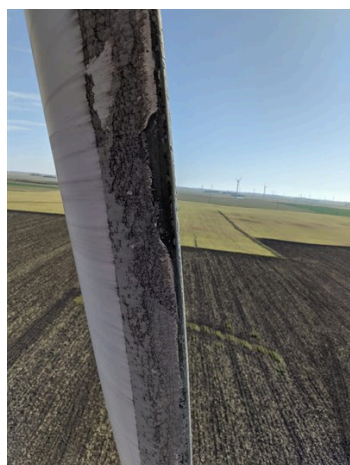
Over time, the leading edge of wind turbine blades become eroded and lose efficiency and power production for the turbine generator. Because of the time of year, the weather was very cold, and a blade repair solution was needed to properly complete the repairs.

- * 1. Damaged leading edge of wind blade ,
- * 2. Belzona 5721 ready to mix ,
- * 3. Finished Belzona 5721 application on leading edge ,
- * 4. View of the Wind Farm ,

The application was carried out in accordance with a modified version of Belzona Know-How System Leaflet FBC-1. The blades were coated on the turbine at the operation site. The pitting and loss of surface on the leading edge was resurfaced with a filler product and rebuilt to dimensions. The surface area was sanded down with a mechanical sander and cleaned with a rag and non-residual solvent cleaner. One coat of Belzona 5721 at 20 mils (508µm) was applied.
