# Damaged Stair Nosing at Distribution Center

ID: 8153

Industry: Commercial Facilities  
Application: FPA-Floor Problem Areas  
Substrate: Concrete  
Products: \* Belzona 4141 ,  
\* Belzona 5233 ,  
\* Belzona 5231 ,

Customer Location: Dallas, Texas  
Application Date: 12/12/2019

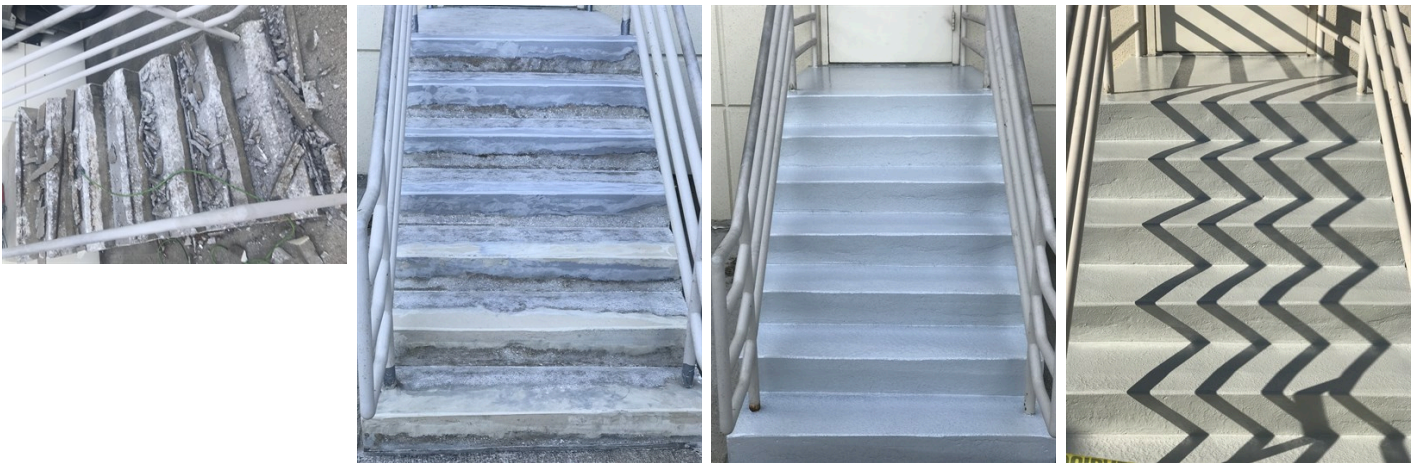
Years of salting the nosings lead to the concrete cracking. The cracks let water in and caused expansion in the concrete and the rebar starting to corrode leading to the steps falling apart. The area is a critical path for the drivers to come in, and causing a safety issue.

- \* 1. Removal of old cracked concrete ,
- \* 2. Application of 4141 ,
- \* 3. Application of 5231 ,
- \* 4. Application of 5233 ,

Substrate was jackhammered to remove all the loose concrete. Once the loose concrete was removed, any exposed rebar was cut out and the area was conditioned with Belzona 4911, in preparation for Belzona 4141. After Belzona 4141 was applied and allowed to cure. then first coat of 5231 was applied. After application, a colour quartz was applied to provide a non-slip surface. Next day top coat of 5233 tinted grey was applied.
