BELZONA REBUILDS SEAWATER FILTER FLANGES

ID: 8155

Seawater filters of a container ship.

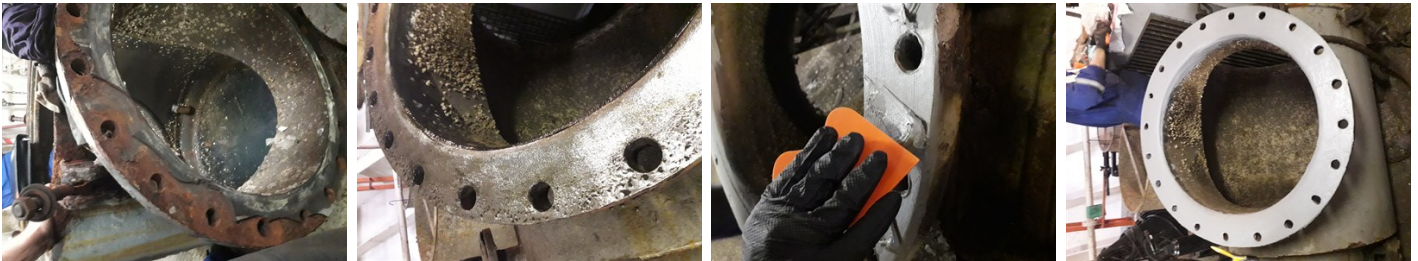
Pitted surface and metal loss due to erosion and corrosion on the seawater filter flange.

- * Erosion and corrosion damage on the flange. ,
- * After surface preparation. ,
- * Application of Belzona 1111 (Super Metal) with applicator. ,
- * After Belzona application. ,

Application was carried out in accordance with Belzona Know-How System Leaflets VPF-01 , VPF-13. Surface was prepared for mechanical bonding and surface was cleaned with Belzona 9111. Immediately following surface preparation, Belzona 1111 was applied to the surface with stiff brush. Then flange surface was recreated with applicator.

Alternative for repairing the flange surfaces is replacement of the flange. Flange replacement will be very costly and time consuming. Another alternative is welding. Welding and machining of the flange surface at workshop is costly and time consuming. Belzona in situ solution for the rebuilding of the damaged areas and prevention of further corrosion was the quick and low cost effective solution.
