REPAIR OF SEA WATER INLET VALVE WITH BELZONA

ID: 8157

Customer Location: Shipyard, ISTANBUL, TURKEY
Application Date: June 2018

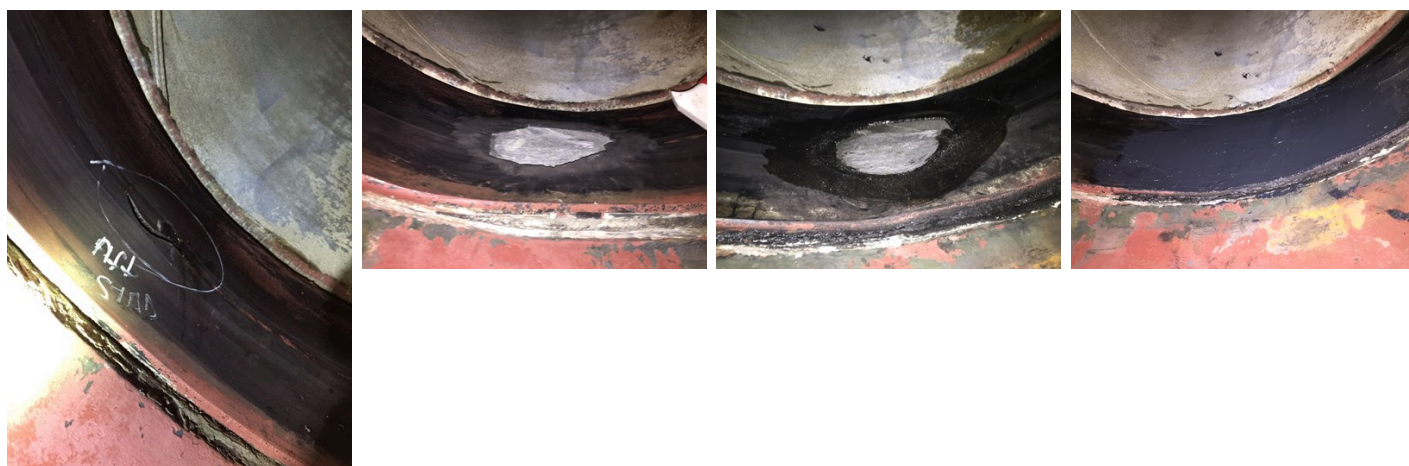
Photograph Descriptions

Sea water inlet valve sealing rubber surface has been damaged. Valve is not sealing properly.

- * Damaged surface of the valve. ,
- * After surface preparation. ,
- * Application of Belzona 2911. ,
- * Application of Belzona 2211. ,

Application was carried out in accordance with Belzona Know-How System Leaflet VPF-03. Damaged rubber surface was undercut and abraded to achieve a mechanical bond. The surface was conditioned with Belzona 2911 and allowed the cure. Then Belzona 2211 was applied and allowed to cure.
