Belzona Protects Tank Legs from Corrosion

Industry: *Food & Drink*
Application: *TCC-Tanks and Chemical Containment Areas*
Substrate: *Mild steel*
Products: ** Belzona 5811 (Immersion Grade),*

Customer Location: *Girvan, Scotland*
Application Date: *April 2018*

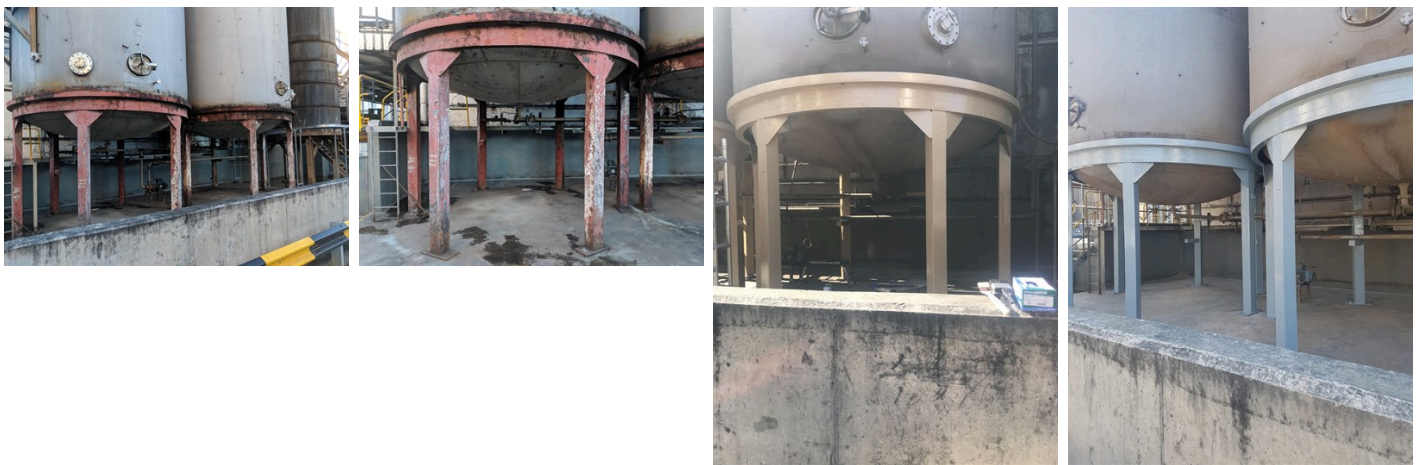
- * Legs before ,
- * Legs before ,
- * 1st coat of Belzona 5811 ,
- * 2nd coat of Belzona 5811 ,

Several tank legs were experiencing corrosion. Around distillation sites a specific fungus that feeds from ethanol grows. This fungus creates a rough surface that traps water against a surface. This particular distillery is close to the sea, meaning much of this water would have salt within it. The combination of these two factors gives great potential for the corrosion of any unprotected metal.

Open blasting was undesirable due to the amount of dust created. Saturation blasting was used to keep these levels down whilst still giving a good surface profile to bond to.

Blasted to SA2.5 & 75 microns using Sat blast system Two coats of Belzona 5811 then applied in accordance with Belzona System Leaflet TCC-06.
