# Abrasion Protection of Linatex Tower

ID: 8162

Industry: General Industry  
Application: SHM-Solids Handling Machinery

Customer Location: Quarry, Scotland UK  
Application Date: 2019

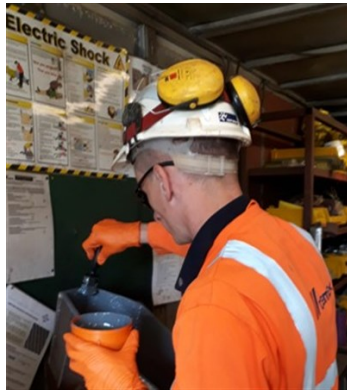
The abrasive qualities of sand had resulted in wear and holes on the steel chute. The equipment only lasted six months before wearing out, so a more permanent solution was required by the client.

- \* Equipment prior to coating ,
- \* Application of Belzona 1321 ,
- \* Tiles grouted in-place ,
- \* Completed application after six months in service ,
