Biomass plant pipe repairs

ID: 8163

Industry: Power
Application: VPF-Valves, Pipes and Fittings
Substrate: Mild steel
Products: * Belzona 1982 ,
* Belzona 9381 ,
* Belzona 9382 ,

Customer Location: Scotland
Application Date: January 2020

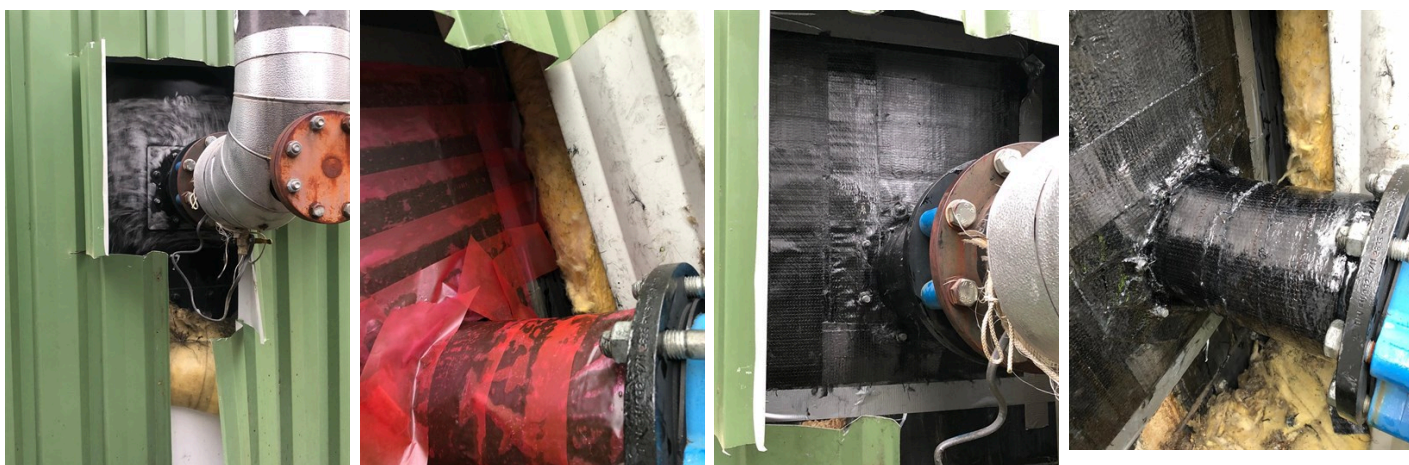
Photograph Descriptions

- * 1 - Surface preparation of tank wall ,
- * 2 - SWII system applied & consolidation tape in application ,
- * 3 - Application on tank wall ,
- * 4 - Application on pipe ,

Following NDT testing of a digester feedpipe, it was found that internal corrosion has caused the pipe wall thickness to approach the minimum allowance. A repair was required to reinforce this pipe without shutting down & dismantling the pipework.

The area was prepared to SSPC SP11 using a mechanical abrasion cleaning process. Belzona 1982 was applied along with Belzona 9381 composite reinforcing sheet. A wrap system was applied to the feedpipe along with a patch system terminating onto the tank. Bracket bolts were patched around. The repair was then consolidated with Belzona 9382. The repair was done on a 'standard' SWII basis.
