Biomass plant pipe repairs

ID: 8163

Industry: Power
 Application: VPF-Valves, Pipes and Fittings
 Substrate: Carbon steel
 Products: Belzona 1982 (SuperWrap II)

Customer Location: Scotland
 Application Date: January 2020

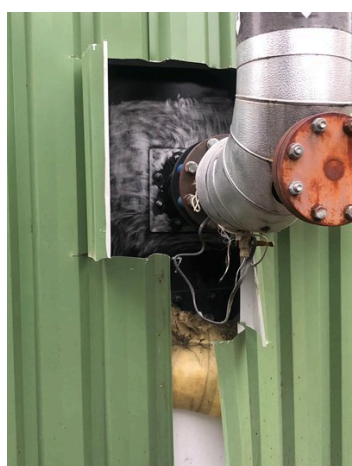
Surface preparation underway

The area was prepared to SSPC SP11 using a mechanical abrasion cleaning process. Belzona 1982 was applied along with Belzona 9381 composite reinforcing sheet. A wrap system was applied to the feedpipe along with a patch system terminating onto the tank. Bracket bolts were patched around. The repair was then consolidated with Belzona 9382. The repair was done on a 'standard' SuperWrap II basis.

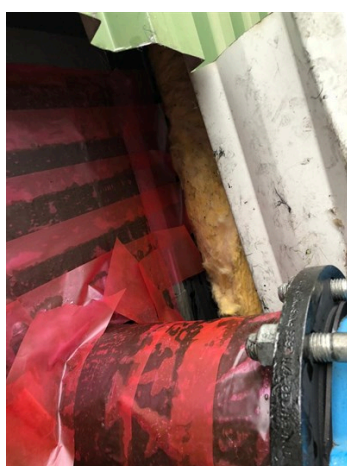
SuperWrap 2 consolidated

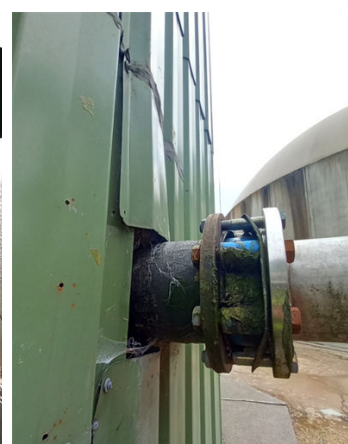
Repair in place 5 years later

Using this system was much safer than welding & much quicker than dismantling & replacing the pipework. The repair was viewed onsite 5 years following the application & is in good condition.
