# Belzona Repairs the Internals of Ball Mill

ID: 8164

Customer Location: Cement Manufacturer, Essex, UK  
Application Date: December 2019

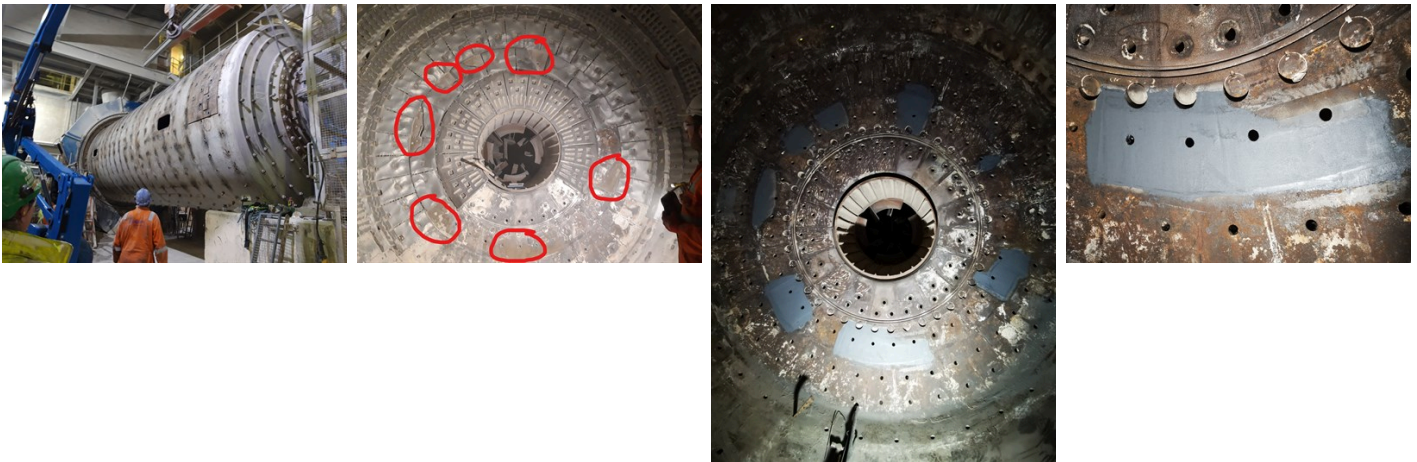
The client was undertaking refurbishment works on one of their ball mills. During inspection it was highlighted that seven localised areas on a dome end internal had damaged plates, which in turn had eroded the substrate resulting in heavy steel loss.

Using conventional grit blasting methods, the substrate was prepared to a standard minimum surface profile of 75µm and a surface cleanliness of SA 2½. The client then rotated the ball mill 180° to allow for the rest of the mill to be prepared. Belzona 1511 was then forced into the blasted profile by brush. This material was then used to reprofile the damaged areas using an applicator and straight edge across good steel to use as a datum. Once all of the reachable areas were repaired, the ball mill was then rotated again by 180° and the remaining repairs were undertaken.
