Belzona Protects New Sea Water Pumps

ID: 8165

Industry: Water / Wastewater
Application: CEP-Centrifugal Pumps
Substrate: Steel
Products: * Belzona 1341 (Supermetalgilde) ,

Customer Location: Lancashire, UK
Application Date: January 2019

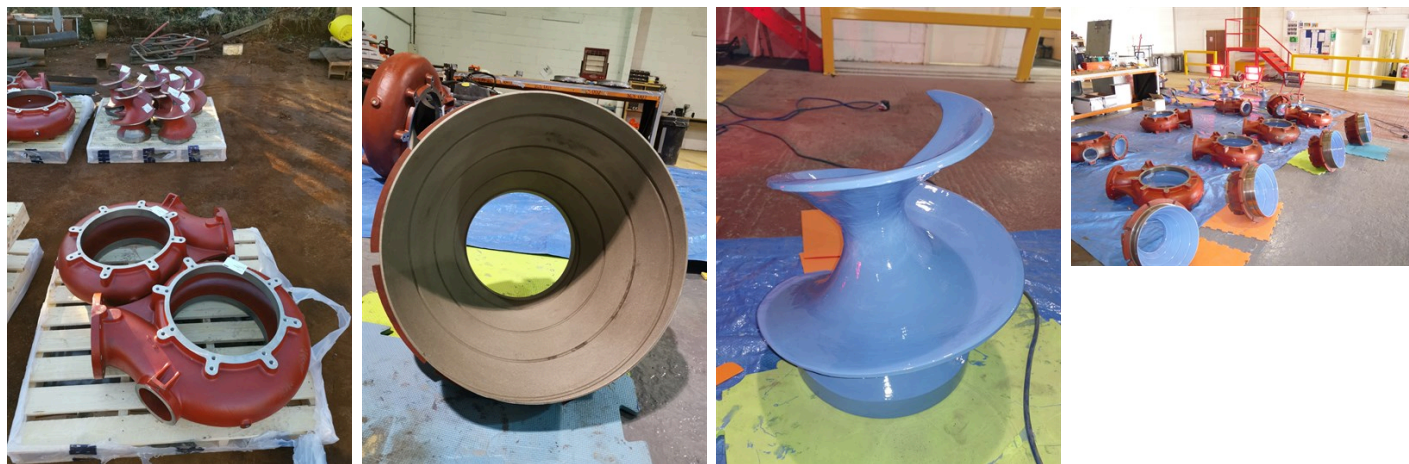
Photograph Descriptions

New pumps requiring internal protection prior to going into service

- * New pump components delivered for protection ,
- * Pieces grit blasted ,
- * Completed application of one of the pieces ,
- * Completed application ,

The application was undertaken in accordance with CEP-01. The pumps were delivered to the Belzona workshop in Wrexham where the team grit blasted the components to SA 2 ½ with a minimal profile of 75 microns. Each of the internal areas were then coated with two coats of Belzona 1341 and allowed to cure prior to returning to the client.
