Belzona apply Internal Lining to Heat Exchanger Shell

ID: 8166

Customer Location: Oil refinery, North West England
Application Date: February 2019

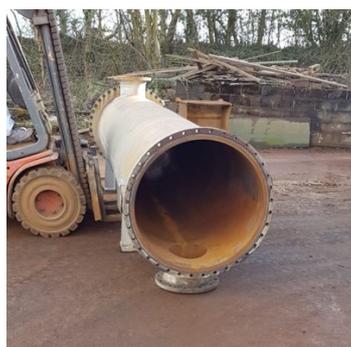
- * Equipment delivered to Belzona Technosol workshop ,
- * Extent of the damage ,
- * First coat of Belzona 1593 ,
- * Second coat Belzona 1593 ,

The heat exchanger was dismantled and delivered to the Belzona workshop in to two parts - the main shell and the dome end. The internal substrate was grit blasted in our workshop under controlled conditions. The pitted steel within the shell was then repaired using Belzona 1511. Following this two Belzona 1511 Nozzle Inserts were bonded into both drain and vent nozzles on the cap end, guaranteeing total encapsulation within these areas. Following the repair, two coats of Belzona 1593 were applied to provide long-term protection. Completed in accordance with Belzona System Leaflet HEX-03

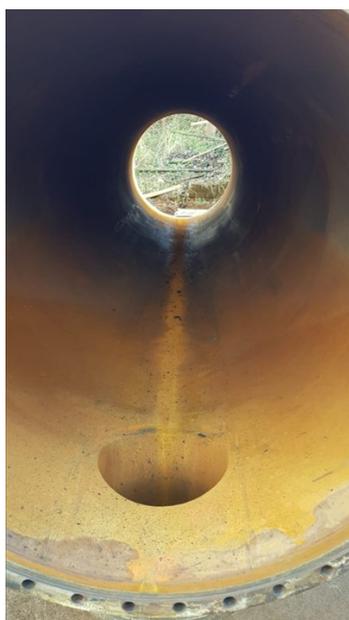
Internal corrosion to the internals of a heat exchanger
